Monitoring Data Record

Project Title: R-2000G (I-540) COE Action ID: 199920387

Stream Name: UT Neuse River (Site 10) DWQ Number: 030114

Monitoring Year: ( 1 ) of 5

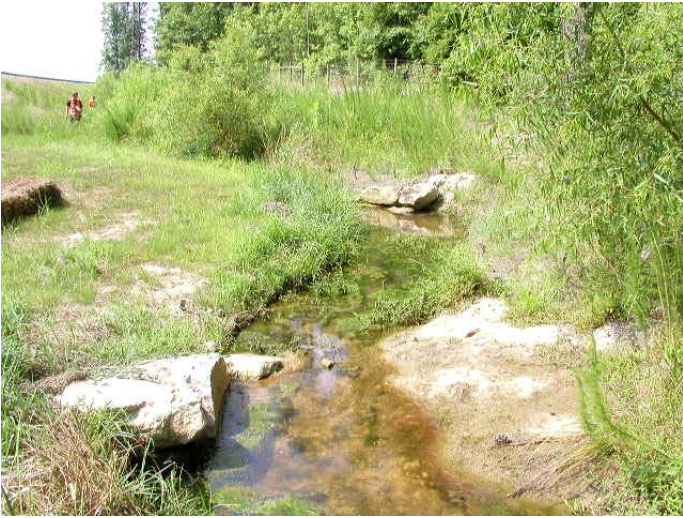
Photo Point #4 (Upstream)

An automobile accident occurred in June 2007 on I-540, which is adjacent to this stream relocation. The accident site carried over the guardrail and into the stream relocation area. Since, the accident has occurred steps have been taking to seed and mulch the area that was disturbed. Photo Point #4 upstream shows the stream relocation area where the accident occurred.

Estimated causes, and proposed/required remedial action: This area will be replanted with bareroot seedlings in the 2008 planting season.

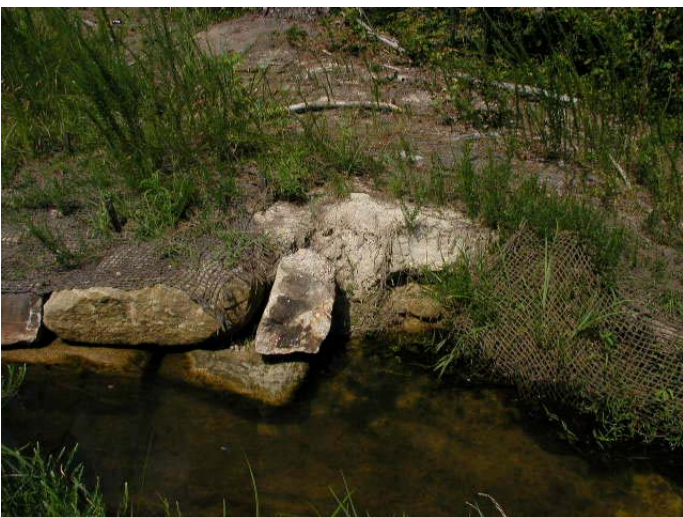
The stream is stable for the Year 1 Summer Evaluation. There is some minor bank erosion on the left bank at the end of a cross vane arm @ Sta. 460+00. This area does not warrant remedial action at this time. NCDOT will continue to monitor this stream relocation.

Bank erosion on left bank at the end of a cross vane arm @ Sta. 460+00  
Year 1 Summer – July 2007
